Recreational Boat Collision Accident Research

Volume 1

Miles A. Beam III, P.E.
Senior Project Engineer
Marine Department

Underwriters Laboratories Inc.

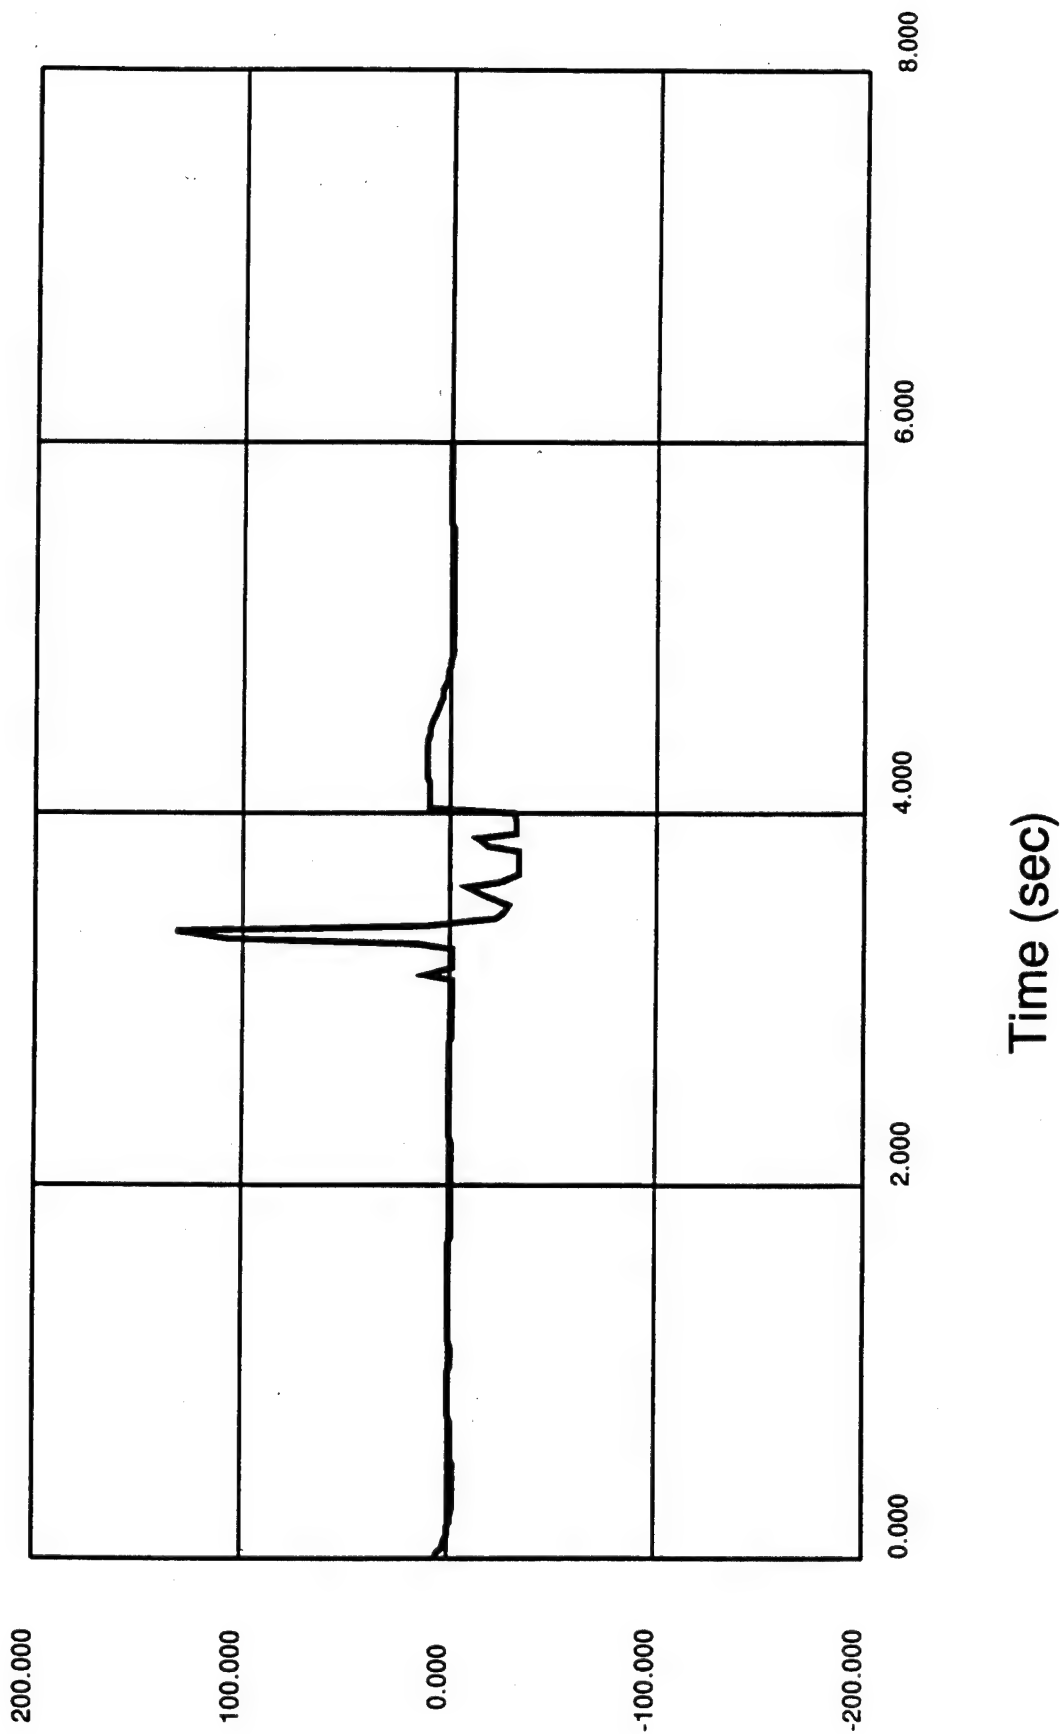
Figure 14-13

Figure 14-12 and 14-13 show the accelerations for the bullet boat in the x and z axis respectively. The units are given in ft/sec². Note that the plot for the z axis shows the pre-impact accelerations at approximately zero. Thus the values obtained from the graph for the z axis must have the component of acceleration due to gravity added for our analysis. This must be done since we are really interested in the forces on the occupants, as calculated from $F = ma$. Thus, components of acceleration for the z axis expressed in feet/per second² will have the value of 32.2 added to them. When acceleration is expressed in g's, the force on an object can be calculated by multiplying this number times the weight of the object. If this sounds confusing, think of the force between the person and the boat if the boat were suddenly allowed to accelerate downward at 32.2 ft/sec/sec. The contact force would be zero! However, if the same boat were suddenly accelerated upward at 32.2 ft/sec/sec, the contact force between the occupant the boat would be two times the occupant weight. Thus, a person weighing 150 lbs would exert a force of 300 lbs on the boat.

Req 2003, Col 3, Bullet Boat Acceleration ($\frac{ft}{sec^2}$)

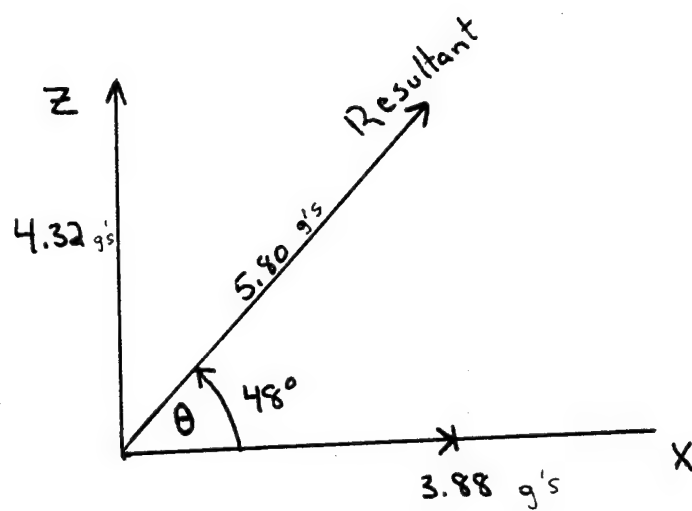
What affect does this have on the occupants? The occupants will experience a force that acts on them opposite to the direction of the acceleration vector and equal in magnitude to their mass times their weight ($F = ma$). Figure 14-16 shows the direction relative to a fixed axis of the maximum experienced acceleration at the CG of the target boat.

Resultant Acceleration Vector of the
Bullet Boat CG During Impact.

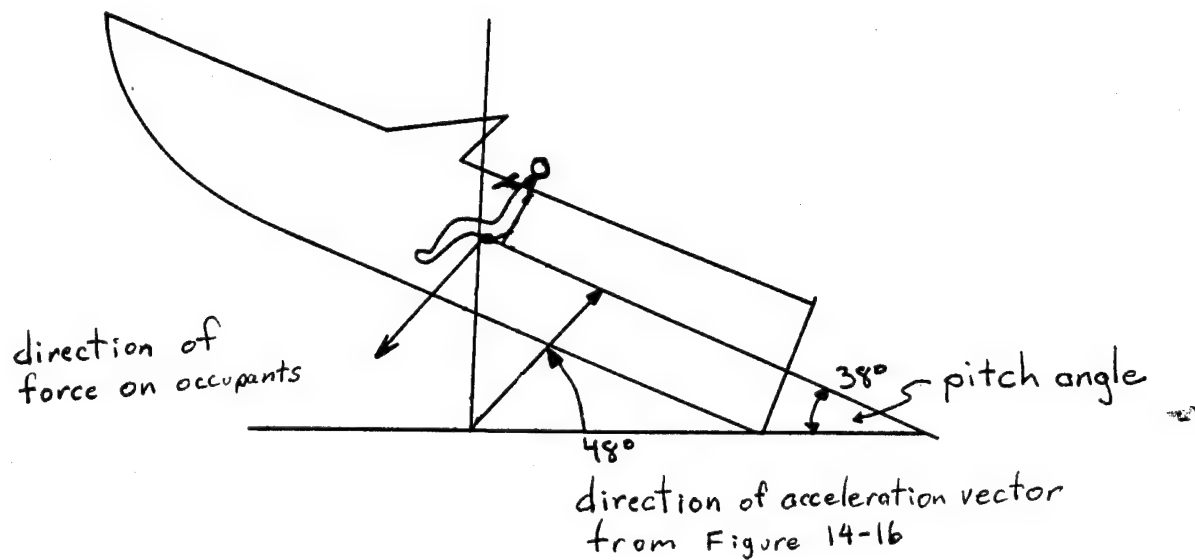
Figure 14-17 shows what the direction of acceleration would be for the values given in the computer model with an increased pitch angle for the bullet boat. In this example, the occupant will feel as though he is being thrust to the floor of the boat. The force is nearly vertical to the trim angle of the boat in this example.

Occupants of the Bullet Boat at the CG Experience a Force Opposite in Direction to the Total Acceleration Vector of the CG.
